RELIABILITY TEST REPORT

Report No: 20201006001

Product Description: nRF52833 Bluetooth Module
Style / Item No.: MDBT50-512K/P512K / No.1, No.2
Manufacturer/ Vendor: Raytac Corporation
Country of Origin: Taiwan
Testing Required: High temperature maintain test
Testing Method: JASO D001-94, Clause 5.14
Quantity: Total 2 sets
Testing Period: Sep. 14, 2020 to Sep. 17, 2020
Testing Results: -Please See Attached Sheets

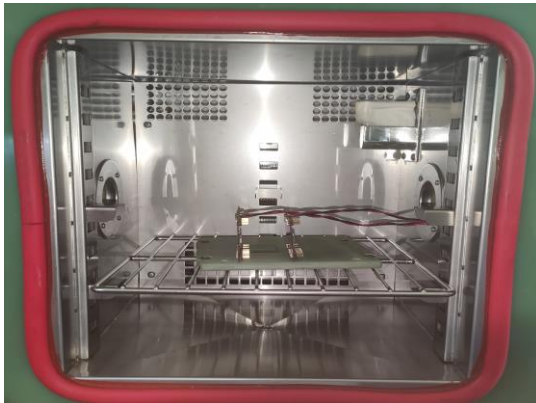
2. High temperature maintain test

Temperature: 105°C

Duration: 72 Hours
