RELIABILITY TEST REPORT

Report No: 20210308002

Product Description: nRF52840 Bluetooth Module
Style / Item No.: MDBT50Q-1MV2/P1MV2 / No.1, No.2
Manufacturer/ Vendor: Raytac Corporation
Country of Origin: Taiwan
Testing Required: Low temperature maintain test
Testing Method: JASO D001-94, Clause 5.12
Quantity: Total 2 sets
Testing Period: Feb. 22, 2021 to Feb. 25, 2021
Testing Results: -Please See Attached Sheets

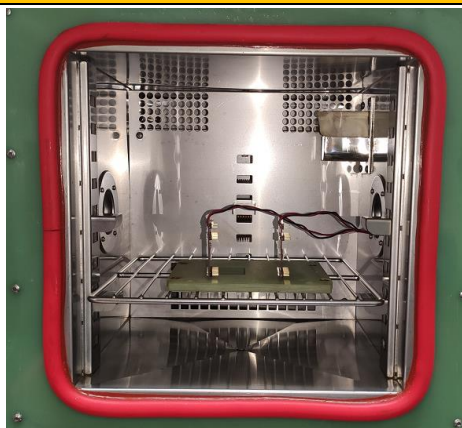
2. Low temperature maintain test

Test method: Refer to JASO D001-94, Clause 5.12

Temperature: -40°C

Duration: 72 Hours

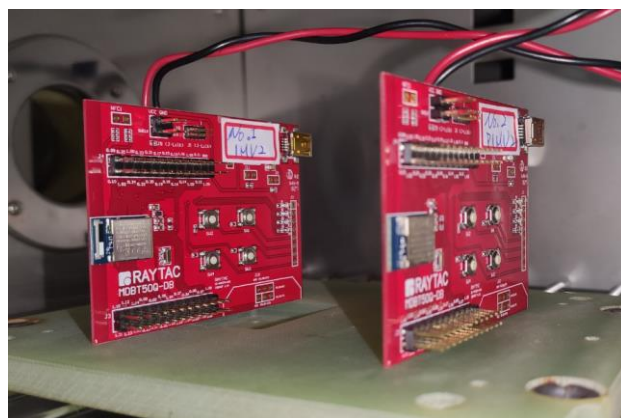
3. Low temperature maintain test
